CANADIAN FORCES FLIGHT SAFETY INVESTIGATION (FSI) REPORT (FSIR)

FINAL REPORT

FILE NUMBER: 1010-12401 (DFS 2-4-2)
DATE OF REPORT: 27 Sep 04

AIRCRAFT TYPE: CH124A Sea King
DATE/TIME: 27 1403Z/1103 R (Local) Feb 03
LOCATION: HMCS IROQUOIS, 41 36N 051 39W (540 NM ESE Halifax)
CATEGORY: "A" Category Accident

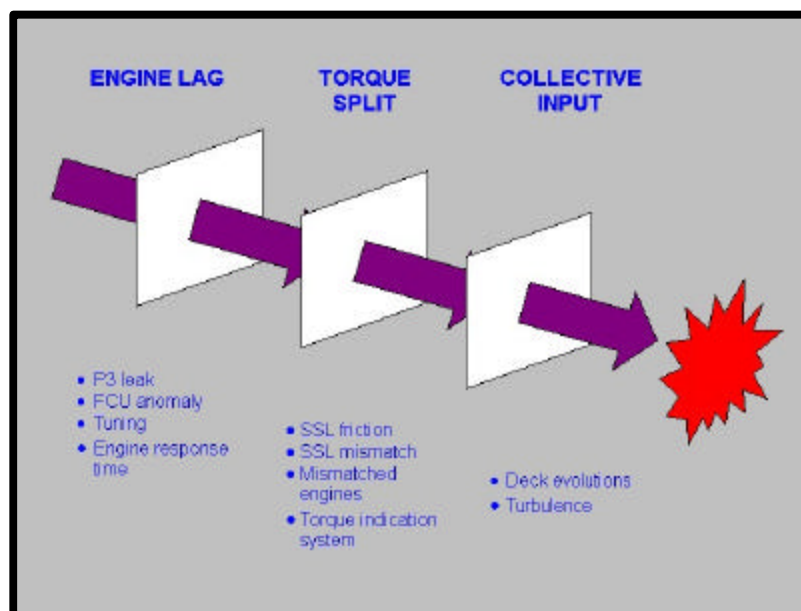
Figure 1: SUTLOT Pre-conditions

SUTLOT can be summarized as the specific combination of several pre-conditions that, when combined with certain technical anomalies, created a load-sharing imbalance that allowed an un-commanded loss of torque to manifest itself, as in the case of CH12434, in a loss of lift. The conclusion of the SUTLOT technical investigation identified the following pre-requisites in Figure 1: SUTLOT Pre-conditions, in order for a SUTLOT occurrence to take place:

Of the Reason's Model representation of the SUTLOT pre-conditions identified in Figure 1, not all of the components were applicable to CH12401. The following breakdown of SUTLOT pre-conditions identifies if applicability to CH12401 existed and provides a brief explanation of the pre-condition itself:

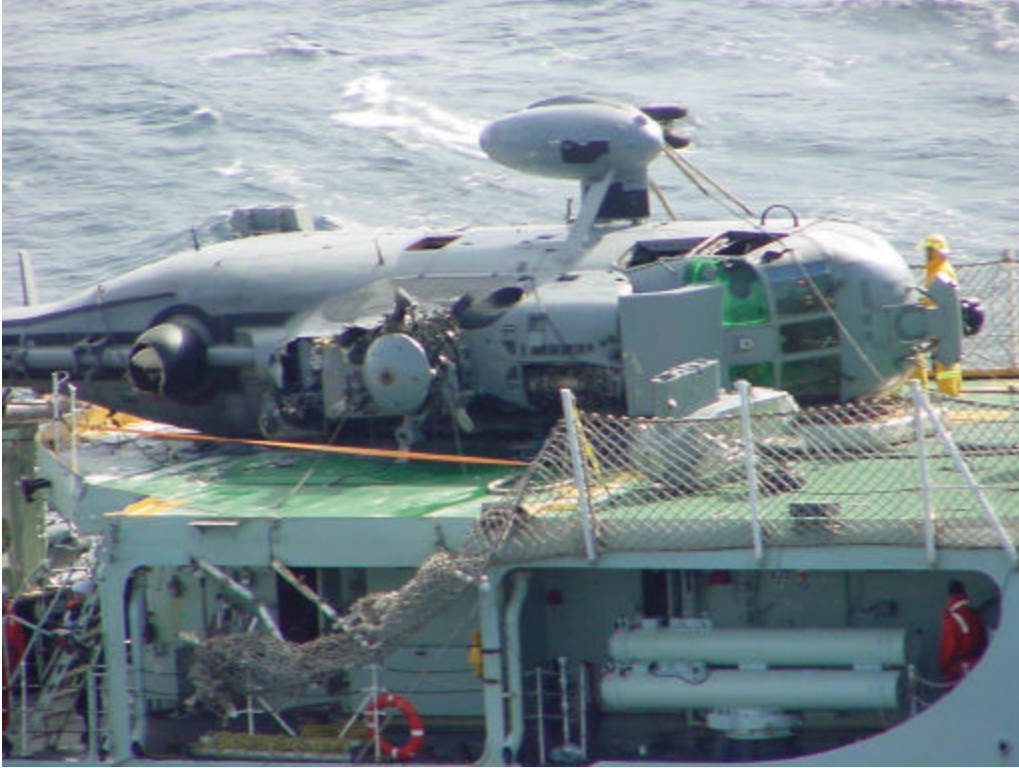
Photo 1: At Rest on the Flight Deck

The right sponson collapsed on impact and completely detached from its mounts. All five main rotor blades sheared off at the blade root due to rotational forces on contact with the flight deck. The tail rotor blades were severely damaged. The radome just aft of the main rotor transmission housing was crushed by rotor blade contact and the tail boom was severed at the pylon hinge by rotor blade contact. The number two engine suffered external impact damage to the oil tank, outer combustion case, and other components. Considerable skin rippling and crush damage on the starboard side of the aircraft occurred as a result of aircraft rollover.

The initial assessment of aircraft damage is "A" category (Photo 1).

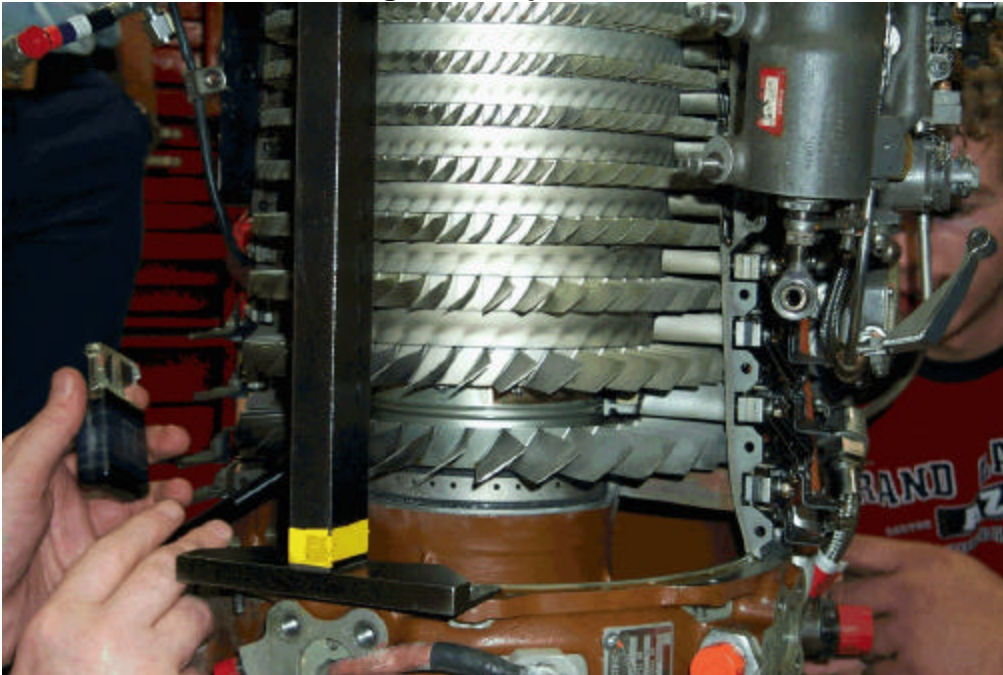
Photo 2: Number One Engine Compressor

The compressor section was found to have slight, non-excessive rubbing, on the top portions of the rub strip. This rubbing was within CFTO limits.
